SuperSport 937
2016-2020
CABLE CLUTCH VERSION

FITTING INSTRUCTIONS
 TO BE FITTED BY A QUALIFIED TECHNICIAN

SECONDARY ALTERNATOR COVER – PART NO. EC-937-2016-1-GBR

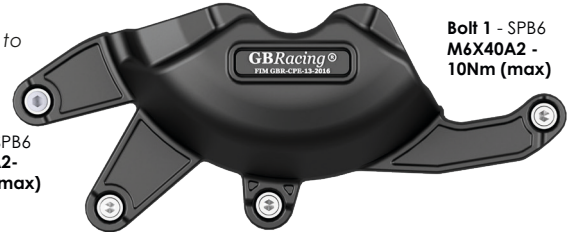
Fig. 2: GEAR LINKAGE ARM

Please note - See Fig.2: Before fitment, please make sure you have a marker pen to mark spline for alignment. The bracket in Fig. 1 must not be removed to fit GBRacing covers.

- 1 Remove fairing.
- 2 Remove bolt 1 on the gear linkage arm (Fig. 2).
Before you remove the upper bolt 2, put a mark on the spline at the bottom of the slot (as shown). Then remove the upper bolt 2 and slide off the gear linkage arm.
- 3 Remove 4 existing bolts from the stock alternator cover, shown in Fig. 1 as position Bolt 1, 2, 3 & 4.
- 4 Place the secondary alternator cover over the stock cover.
- 5 Assemble 4 replacement bolts loosely in the correct position as shown in Fig. 1.
- 6 Tighten bolts to a Torque of 10Nm as per Manufacturer's recommendations. DO NOT OVERTIGHTEN.
- 7 Put the gear linkage arm back on the spline, ensuring the slot lines up with the mark you made earlier (Fig. 2).
- 8 Re-fit the push rod through the bottom of the arm as in Fig. 2 then reinstall bolt 1.
- 9 Re-fit Fairing.

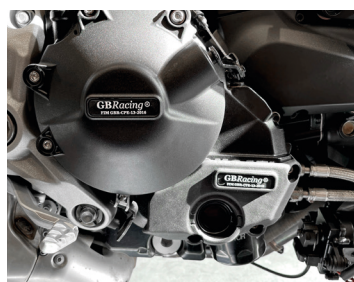
SECONDARY OIL INSPECTION COVER – PART NO. EC-937-2016-4-GBR

- 1 Remove fairing.
- 2 Remove 3 existing bolts from the oil inspection cover, shown as position Bolt 1, 2 & 3.
- 3 Place the secondary oil inspection cover over the stock cover.
- 4 Assemble 3 replacement bolts loosely in the correct position as shown.
- 5 Tighten bolts to a Torque of 10Nm as per Manufacturer's recommendations.
DO NOT OVERTIGHTEN.
- 6 Re-fit fairing.

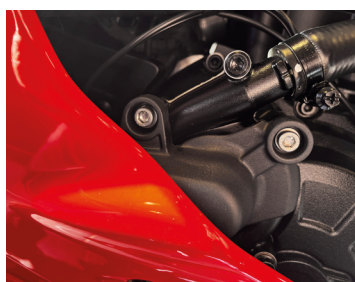
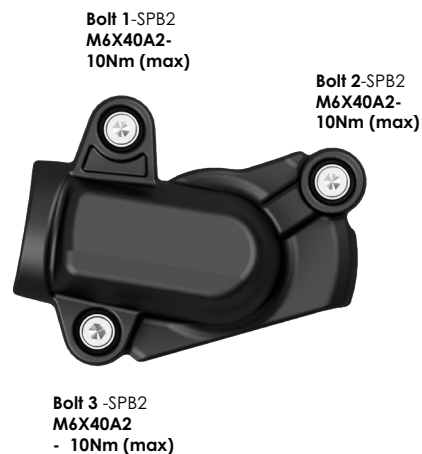
SECONDARY WATER PUMP COVER – PART NO. EC-937-2016-5-GBR

- 1 Remove fairing.
- 2 Remove 3 existing bolts from the water pump cover, shown as position Bolt 1, 2 & 3.
- 3 Place the secondary water pump cover over the stock cover.
- 4 Assemble 3 replacement bolts loosely in the correct position as shown.
- 5 Tighten bolts to a Torque of 10Nm as per Manufacturer's recommendations.
DO NOT OVERTIGHTEN.
- 6 Re-fit fairing.
